# Statue of Liberty Upgrades to plastic

## AT A GLANCE

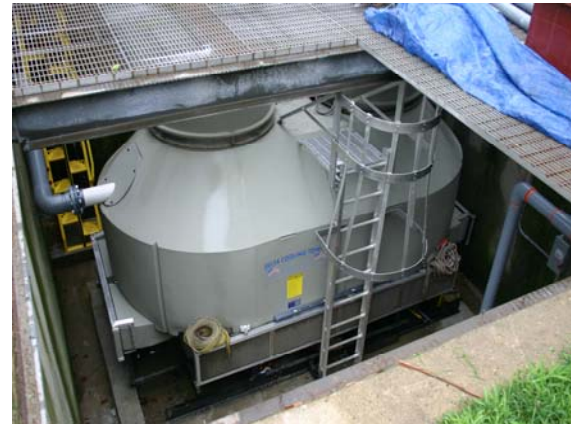
*The 250-ton Premier tower chosen to cool the museum area of Lady Liberty*

Over the span of six weeks, Culkin and the five-member C&S team installed a 250-ton Premier tower to cool the museum at Liberty Island, while a smaller 70-ton Paragon tower was installed to cool the interior space of the Statue of Liberty. HVAC service technicians performed a controls upgrade to the HVAC system including replacing pumps, disconnect switches, and all steel piping on the outside of the statue.

The installation of the plastic towers allows for fewer support materials because the plastic towers are built directly into the steel frame. Along with a reduced number of support materials, the plastic cooling towers' direct-drive Premium Efficiency fans and a 15-year casing warranty provide several design advantages over conventional models. The seamless, one-piece shell eliminates panels, rivets, or hundreds of fasteners that can weaken and deteriorate the internal structure of the tower. In particular, in such a harsh, damp environment, the seamless plastic towers keep water and moisture away from the vital parts of the tower.
